**Assessment of Likely  
Arboricultural Impacts  
Proposed storm water storage tank and associated works  
Balheary Road,  
Swords,  
Co Dublin**

**January 2022**

**Re. Request for Additional Information regarding**  
**Trees adjoining proposed**  
**storm water storage tank and associated works area**  
**Balheary Road, Swords, Co Dublin**

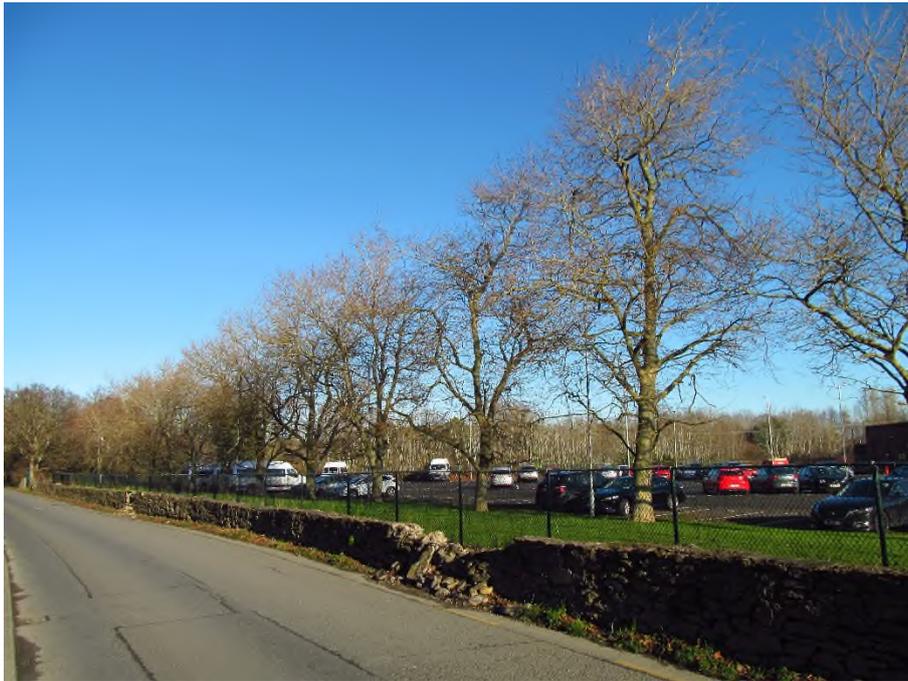
**Photo 1**

A group of 11 young London Plane, setback circa 10.00 m from the eastern side of the Balheary Road. These young trees are in generally good condition and assert root protection areas typically not exceeding 5.00 m. Accordingly, these trees can be regarded as being physiologically detached from the proposed work zone.

Tree Group 1, A group of London Plane set back to east of Balheary Road. At this range, these trees will be unaffected by works within roadway.

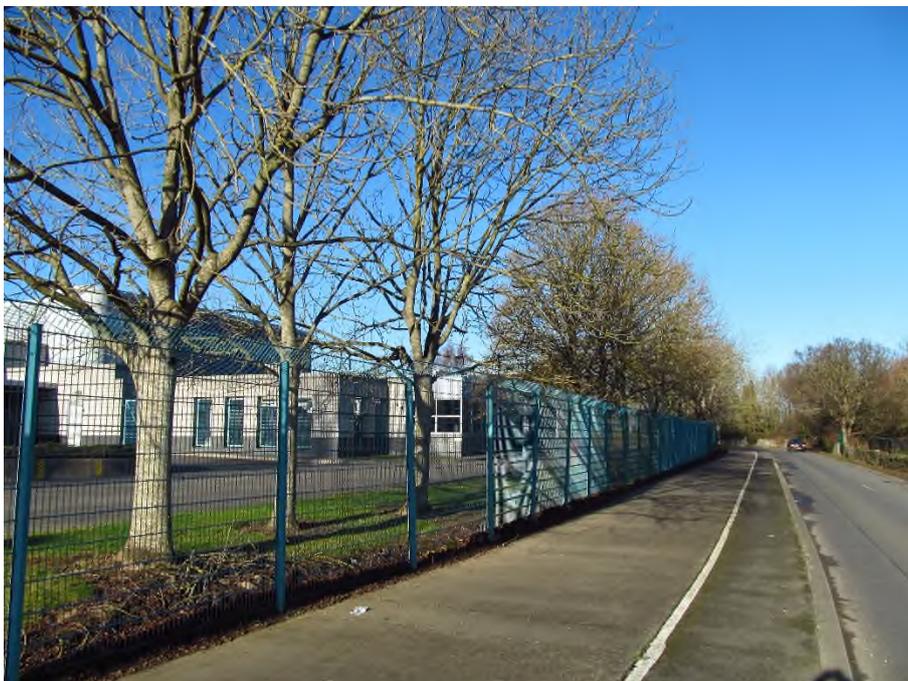
**Photo 2**

An alignment of 12 young trees including 8 ash and 4 field maple. These young trees are in broadly good condition however, some concern attaches to the ash in light of the prevalence of ash and dieback within the greater Dublin area. Accordingly, the sustainability of the ash portion of this population cannot yet be regarded as being sustainable and it is advised that the ash are reviewed on a regular basis.

Notwithstanding the proximity of these trees to the site boundary and roadway, ground conditions are considered such as to be likely to have greatly curtailed natural root spread. Considering anaerobic conditions and limited percolation associated with these cement surfaces, is considered likely that tree roots will have developed a proliferated within areas of open ground stop combining the size of the trees in question as well as the features between the trees and the road edge, it is considered highly unlikely that any root material will have reached the roadway corridor.

Tree Group 2. Located closer to the roadway, but are separated by a substantial pavement. Root development beneath the pavement will be highly limited, meaning that works within the roadway are unlikely to have minimal if any effect on the trees.

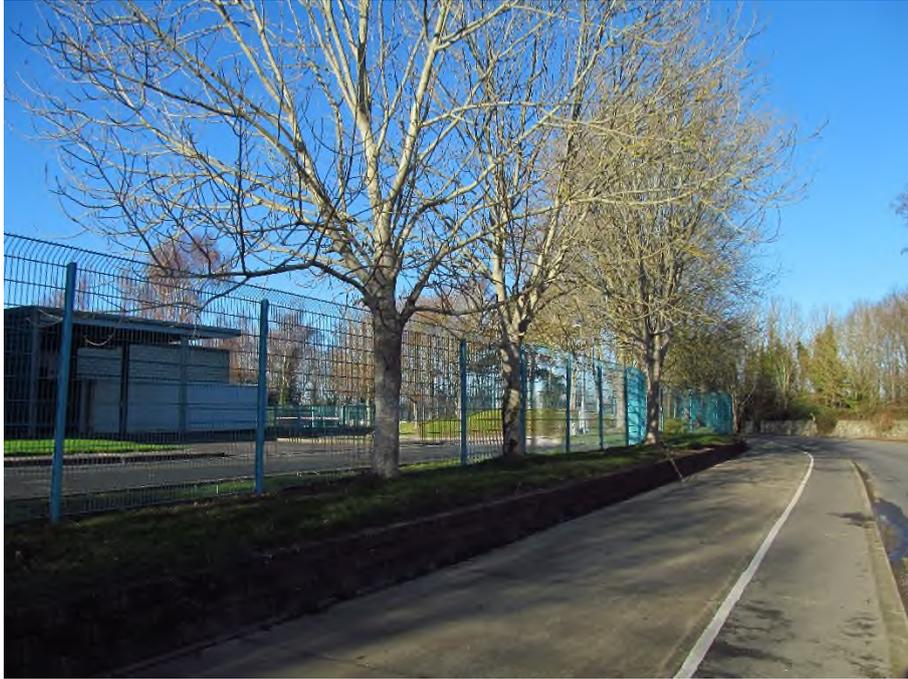
**Photo 3**

This group is effectively a continuation of “Tree Group 2”. The group includes 9 Ash and 2 Field Maple in positions adjoining the roadside boundary. These trees differ from those in tree group to in that they arise from elevated positions relative to the roadway. Under the section, tree bases are circa 400 mm above pavement levels whilst at the northern end in close to the museum entrance, tree bases are in excess of 1.00 metre above adjoining pavements.

The considerations with regard to separation from the road exist in this instance but are exacerbated by the dramatic change in ground levels. It is considered highly unlikely that tree roots from these trees will extend much beneath the public footpath and are considered highly unlikely to reach any positions near the roadway.

Tree Group 3. Continuing from tree group 2, these trees are further separated from the roadway by a retained “step” feature ranging from 400 to more than 1000mm in height. This combines with the adjoining pavement suggest that works within the roadway will not affect the trees

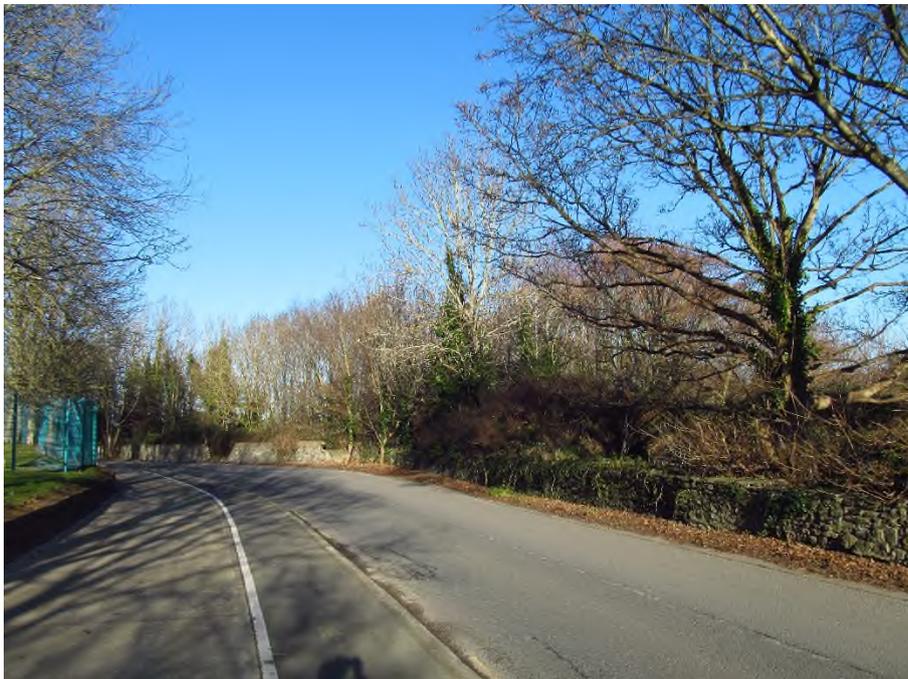
**Photo 4**

This review area involves the westernmost edge of a substantial woodland thicket, extending considerably to the east. Review of individual trees notes a typically young age profile with substantial age similarities. The species encountered suggest natural thicket redevelopment subject to a hiatus in historic land management. The clear majority of trees appear to be in good general condition however, and is raised in respect of “Tree Groups” 2 and 3, some concern attaches to the Ash population in light of the prevalence of ash and dieback within the greater Dublin area.

A clear majority of trees currently appear to be of good health and notwithstanding the issues relating to Ash, would offer substantial sustainability. These trees arise from varying positions and ranges from the road edge however, a small proportion arise from positions within 1.00 m of the road.

It is considered highly likely that the soft margin associated with the road edge will have been colonised by tree roots. Areas beyond this particularly extending to the west beneath the road surface likely to see a rapid diminution of tree roots in line with increasing bulk density and rates of compaction. In this respect, it is considered unlikely tree roots will extend for any great range beneath the road and that the extent and quantum of tree roots extending beneath the road edge will diminish rapidly. Furthermore, joints, strips and anomalies within the root surface would suggest that the road edge, and possibly the soft margin adjoining the road edge has been previously disturbed, this factor appears to be borne out by the existence of underground utility service hatch covers in the general area. Additionally, it is noted for much of this length of the roadway, there is in existence of the stone wall. But the stone wall have been repaired with cinderblock formations, suggesting a need for prior intervention and foundations whilst the Stonewall itself will be considered to provide only minimal obstruction to tree root development, it will nonetheless have some effect.

Tree Group 4. This comprises a broad and variable area of wood thicket, typically dominated by relatively young trees.

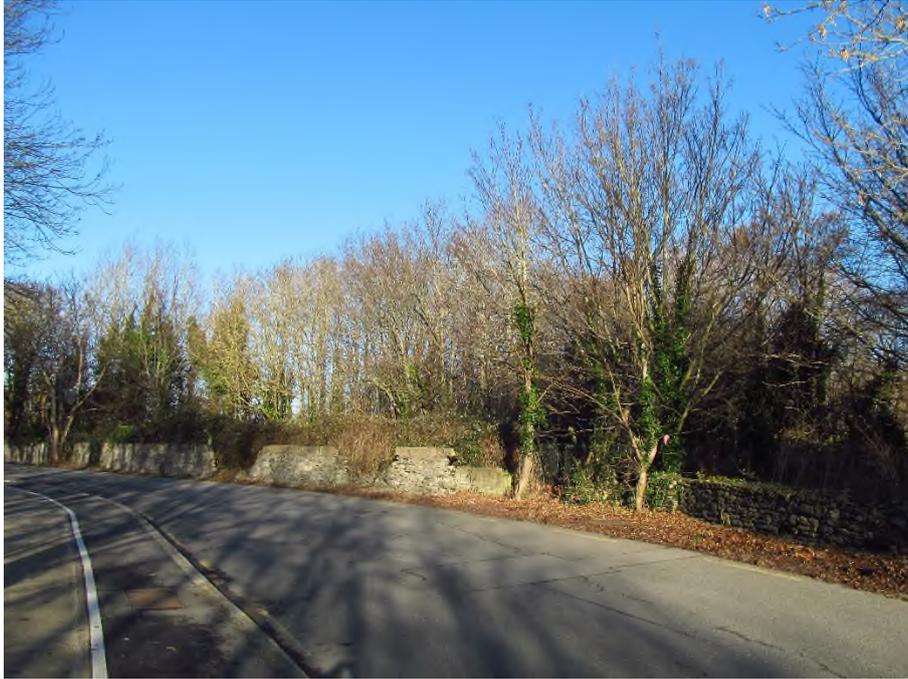
**Photo 5**  
Tree Group 4. This comprises a broad and variable area of wood thicket, typically dominated by relatively young trees.

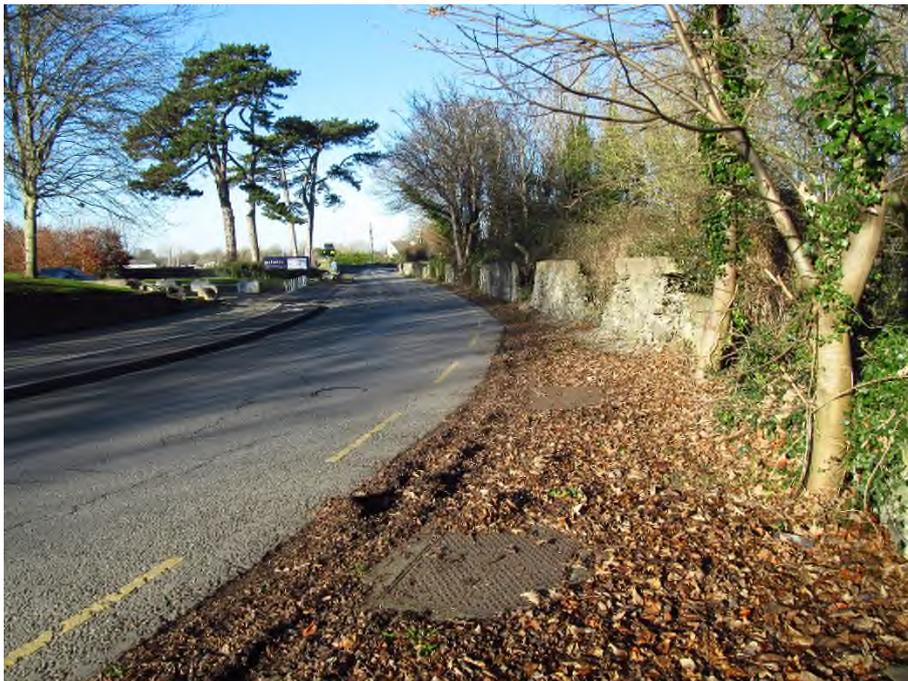
A group of four mature and typically good quality Austrian Pine, located to the west of the existing roadway. These trees tend to be setback from the road edge and separated from the road edge by a wall of relatively recent construction relative to stone walls noted elsewhere within the area. The two southernmost specimens located at circa 8.00 m back from the road edge considered such as to present little potential of tree roots extending to that position. The two northernmost specimens located close to the riverbank and bridge abutment and as such opposition beyond any likely impact of the proposed works that would have, at this point, turn towards the north-east and the proposed water outfall.

**Photo 6**  
Tree Group 4 and 5. This image illustrates the 4 Austrian Pines of tree group 5. It also illustrates the existence of known underground services, apparently running within the soft margin along the eastern edge of the Balheary Road. This suggests a high likelihood of prior tree root severance and disturbance.

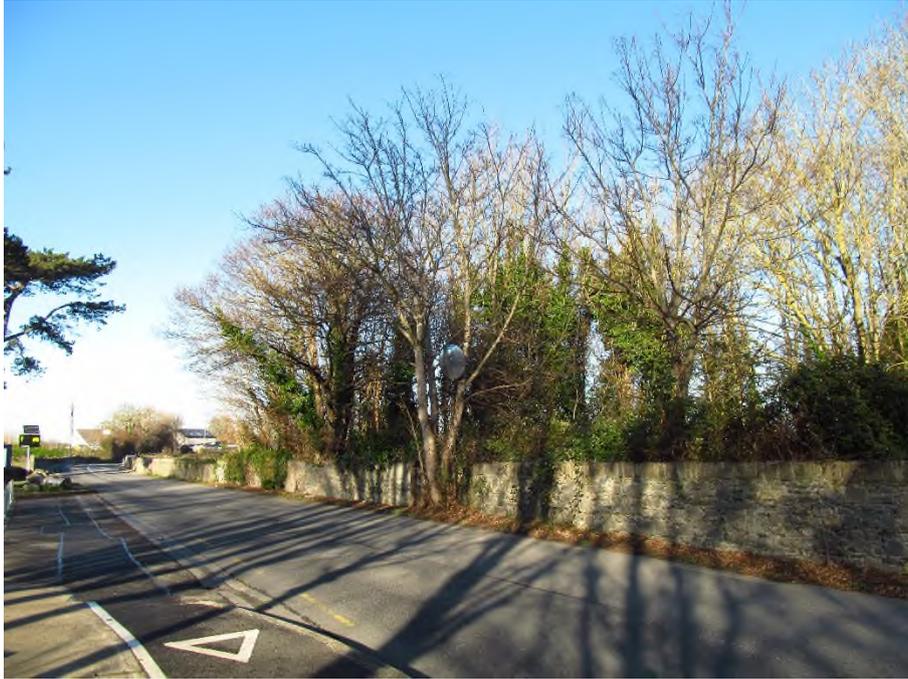
**Photo 7**

Tree Group 4. This image illustrates the broader tree group, as well as the individual Sycamore positioned opposite the entrance to the National Museum of Ireland collection resource centre. While the apparent existence of underground services suggests prior root cutting, the proximity of this tree to the roadway would require particular review at excavation time.

It is advised that due consideration is given to the sustainability of the two young Sycamore adjoining the telecoms inspection hatches, and the Sycamore opposite the entrance to the National Museum facilities.

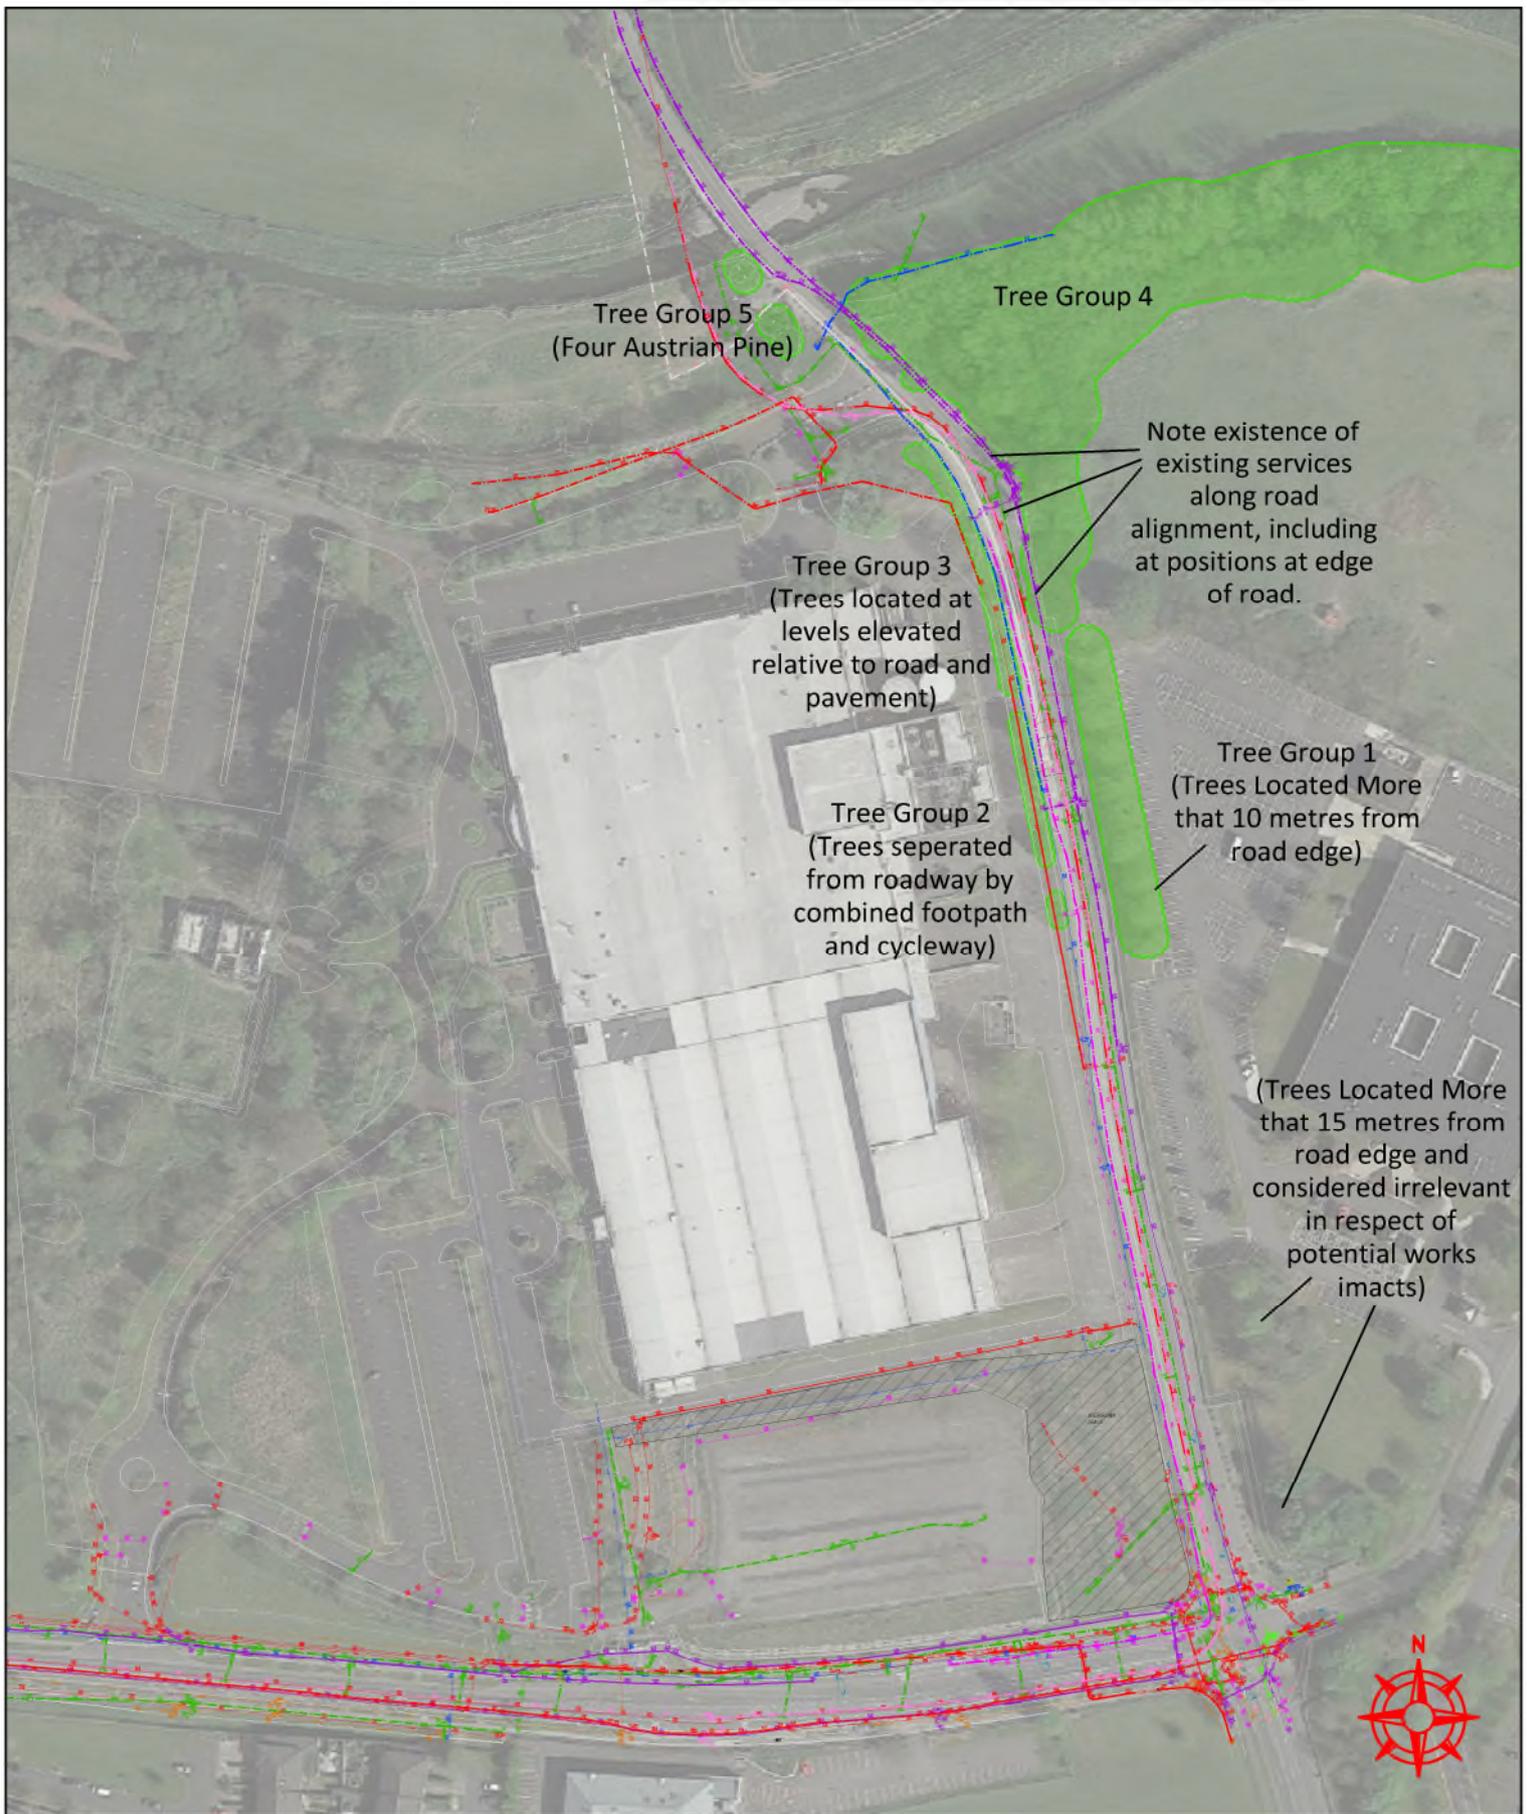
Fig 1.

Note should be made that the works area supports no trees, but there are trees located on lands to both the east and west of the works area.

This drawing illustrates the fact that the proposed services route supports numerous pre-existing underground services, indicating prior intervention and apparent trenching.

The location of the proposed tank raises no Arboricultural issues. The proposed services run to the outfall, being within the existing and services corridor appears unlikely to result in tree damage. It is nonetheless advised that the excavations are progressed with care and under Arboricultural inspection, so that any tree root encountered can be evaluated and responded to in a correct and necessary manner.
